THE DEFORMATION MONITORING SYSTEM ON THE BRASA OVERPASS IN RIGA

Abstract

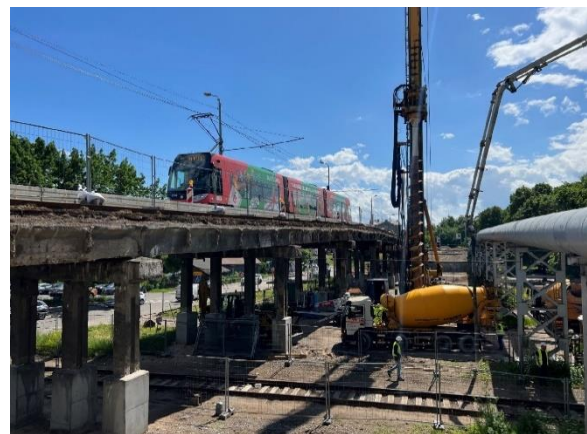
Figure 1. Half of old Brasa overpass, and pail drilling for new construction.

For the construction of a new overpass, there was no available space, necessitating the erection on the site of the old overpass 'Figure 1'. This entailed a singular approach: dismantling the old overpass in two phases. Following the removal of the first half, construction of the new overpass commenced, whilst tram movement

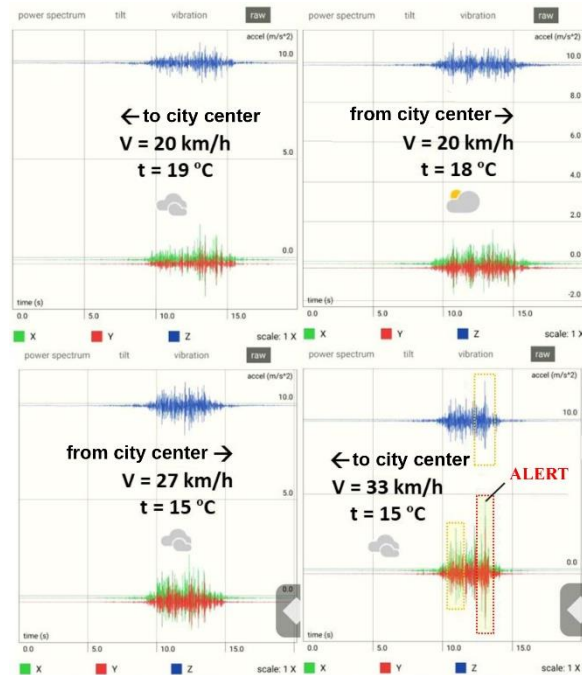
Figure 4. Diagrams from experiment with tram speed.

An example of sensor reporting is depicted in ‘Figure 4’. These deformation graphs were obtained during the testing of the entire system by operating trams in various directions at different speeds. Through this experiment, a safe speed regime for trams was established, which did not induce critical deformations in the span beams. Trams were strictly prohibited from exceeding a speed of 30 km/h. Occasions occurred during operation where drivers exceeded this speed limit, imposing additional load on the structure, which was recorded by the system and, in conjunction with video surveillance, violators were identified and subjected to sanctions.

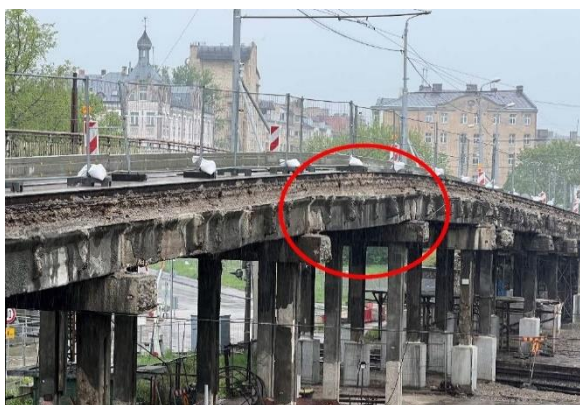
Figure 5. Deformation of the overpass span beam.

Geodetic measurements using a total station revealed deformations in the central beams following the dismantling of half of the overpass. It can be assumed

with high probability that the cross ribs of the beam structure provided stiffness to the entire span. After the demolition of half of the structure, the central beam assumed the role of the outer beam, lacking the stiffness provided by the lost ribs, as illustrated in ‘Figure 5’. Consequently, surveyors were compelled to supplement their survey with monthly levelling of the tram rails to ensure that the span structure did not continue to deform.
