## DEVELOPMENT OF A CALIBRATION STAND FOR DEFORMATION SENSORS TESTING

In the 21st century, there is an increasing number of tasks that we allow electronics to perform autonomously. The monitoring of structural deformations is increasingly entrusted to automated systems based on high-precision sensors connected to monitoring systems. Engineers must be confident not only in the correct selection of the system and its components but also in the accuracy of the measuring sensors, which are at the forefront of deformation monitoring systems. This paper presents a comprehensive study on the calibration and accuracy verification of deformation measurement sensors used in structural health monitoring (SHM). Specifically, the focus is on accelerometers, inclinometers, and dynamic displacement sensor. The calibration process involves rigorous static and dynamic testing to ensure precise measurement capabilities. A test stand with the capability to control the deformation of the span was fabricated, enabling the comparison of real-life measurements with the data obtained from the sensors. The displacement sensor, accelerometer and inclinometer are subjected to controlled laboratory condition

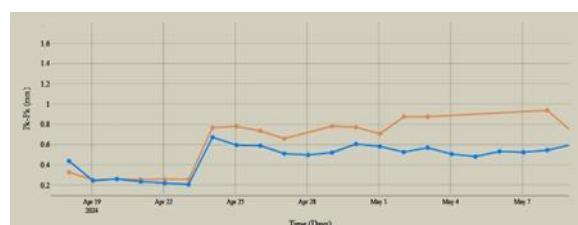
### Figure 1

*Deformation readings from two different DDS sensors installed in the same location*

During the analysis of data collected over a one-month observation period, discrepancies were observed between the two sensors, as illustrated in (Figure 1). This led to the conclusion that the sensors exhibit measurement errors, which may compromise the accuracy of long-term structural degradation assessments.

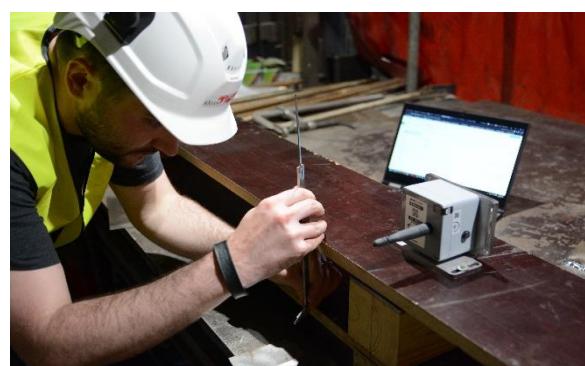
**Figure 3**  
*Adjustment of deflection using iron plates and a vernier caliper*

A total of ten primary tests were conducted, during which the readings from different types of deformation sensors were recorded and compared with the measurements obtained using the vernier caliper.

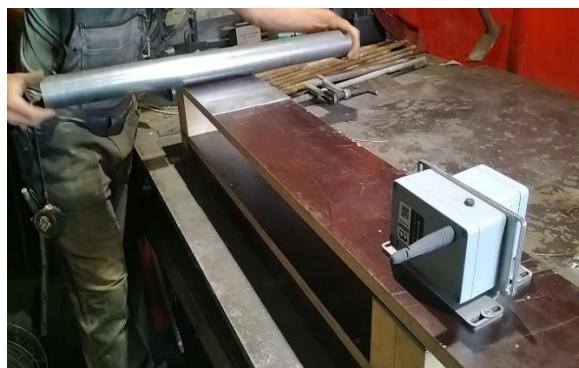
**Figure 4**  
*Expansion joint simulating*

Beyond the primary tests, additional measurements were performed using a cylindrical iron mass, simulating a heavy vehicle travelling across a bridge. In these experiments, deformations gradually increased as the cylinder moved towards the centre of the stand. To introduce further oscillatory disturbances, a metal plate was placed at the beginning of the beam, simulating a heavy vehicle crossing an expansion joint (Figure 4).

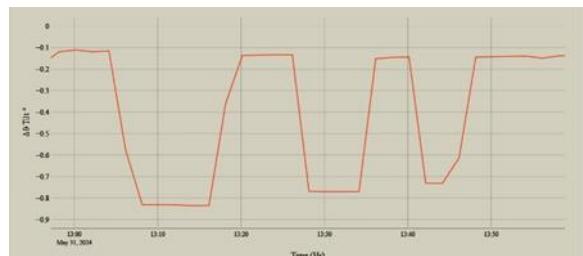
**Figure 6**  
*Inclination test*

During the inclination angle test, the gap of the stand was set to 10 mm, resulting in an inclination angle of -0.57 degrees at a distance of 1 meter. The sensor readings at the upper position of the span indicated an angle of -0.1 degrees, suggesting that the table supporting the stand was not perfectly level. Consequently, the inclinometer readings should have displayed -0.67 degrees. The graph shown in (Figure 6) illustrates that, although minor variations are observed during identical oscillations, the average sensor readings correspond to the calculated inclination angle. Therefore, no correction to the inclinometer measurements is required when applied to the real structure and the sensor can be safely reinstalled on the Kalnciema Bridge.
